METALS HANDBOOK

VOL. 9
FRACTOGRAPHY AND ATLAS OF FRACTOGRAPHY

8th EDITION

Fractography and Atlas of Fractographs

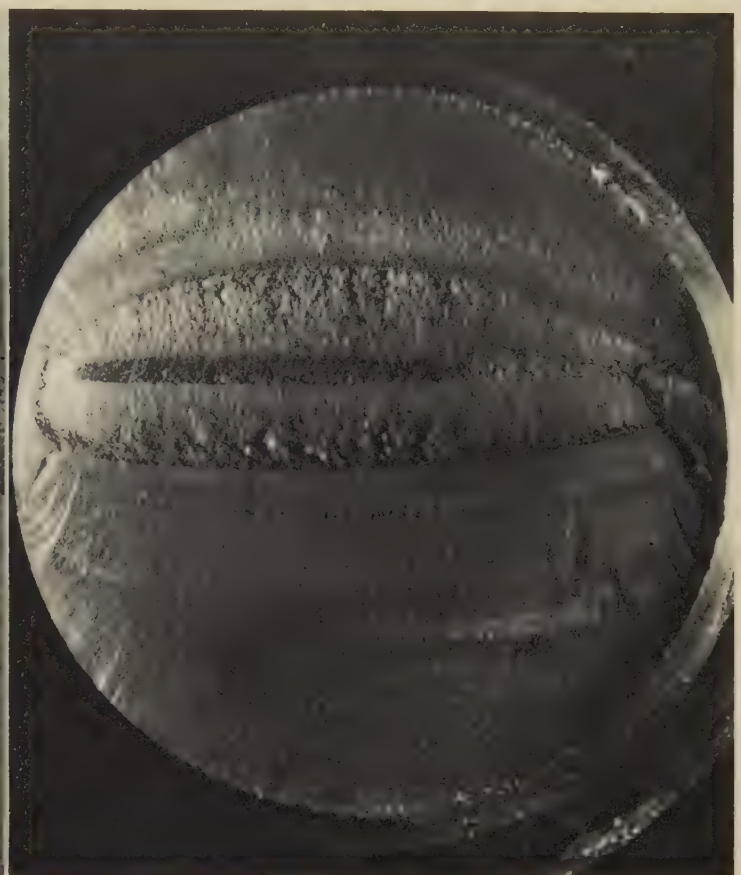
Light fractograph 5×
5037 View of the fracture surface of the steering-knuckle spindle in 5036. Several fatigue cracks originated at the surface of the spindle, at both top and bottom. These cracks began in slightly different planes but, after penetrating a short distance, joined to form two continuous crack fronts.

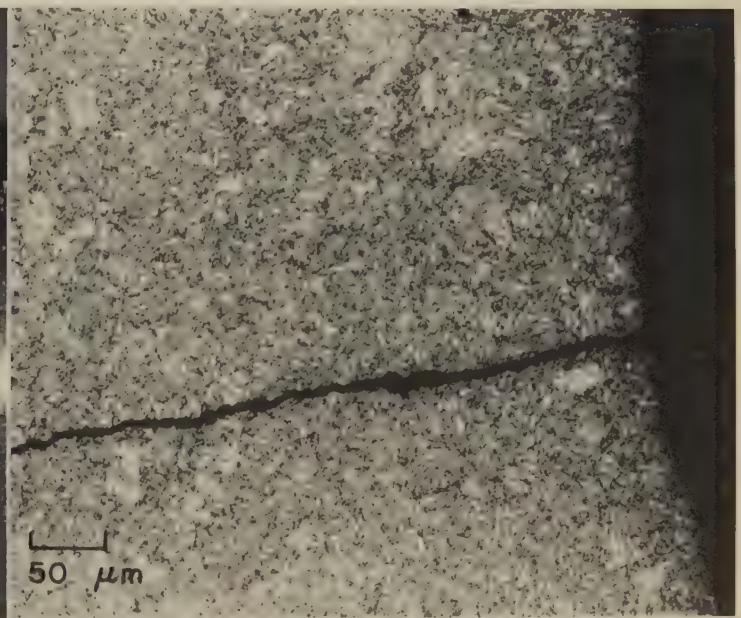
Micrograph (2% picral) 200×
5039 Polished and etched section through the crack in the spindle shown in 5038 (left). The crack, which appears to be transgranular, originated in the root of a fillet in which transverse machining or grinding marks were found. Fracture in 5036 was attributed to stress concentrations caused by such marks.

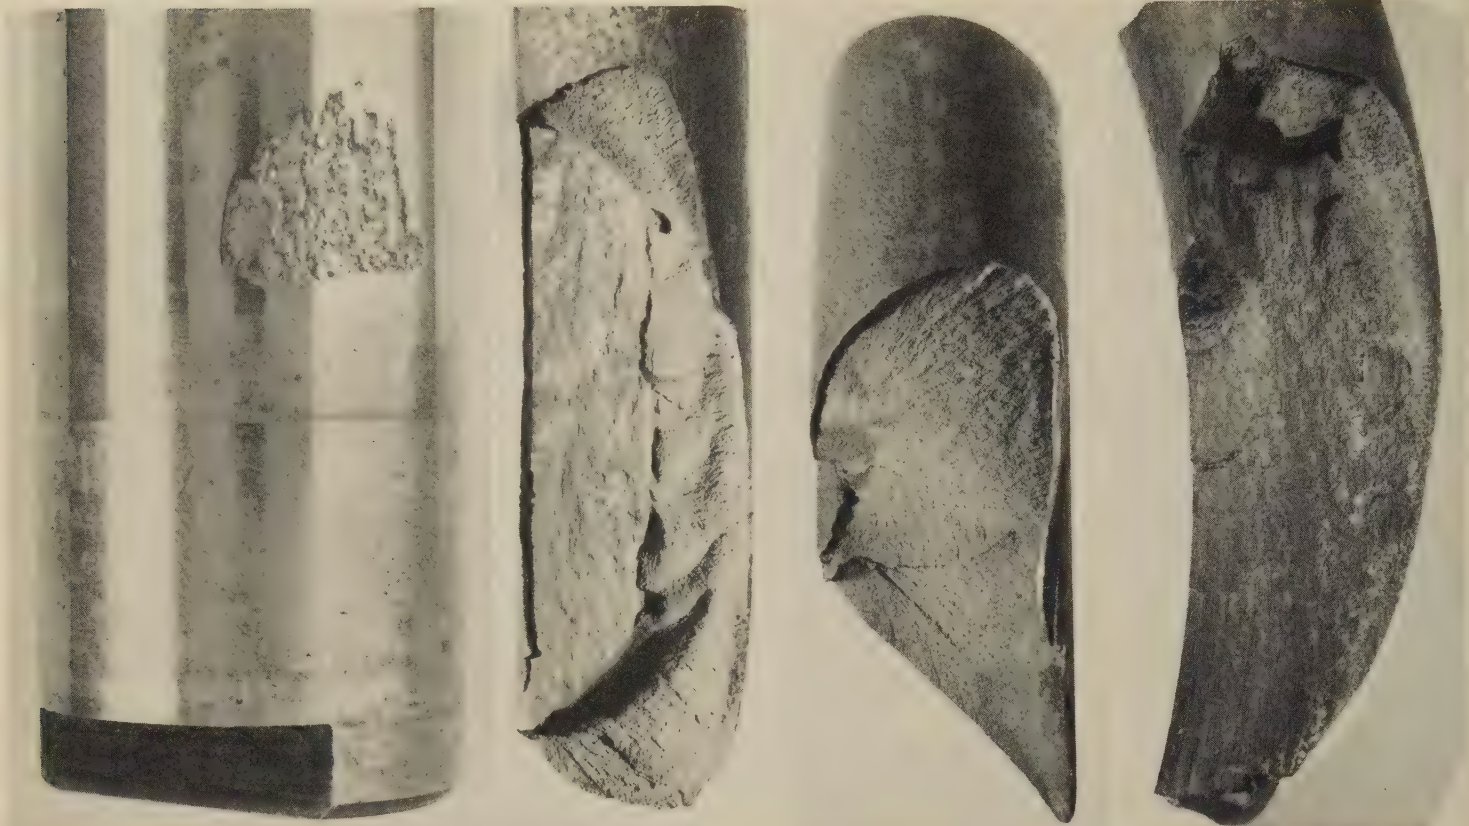
5040 Fretting, caused by a combination of friction and corrosion, on a shaft of 5145 steel that was heat treated to a case hardness of Rockwell C 62 and a core hardness of Rockwell C 55.

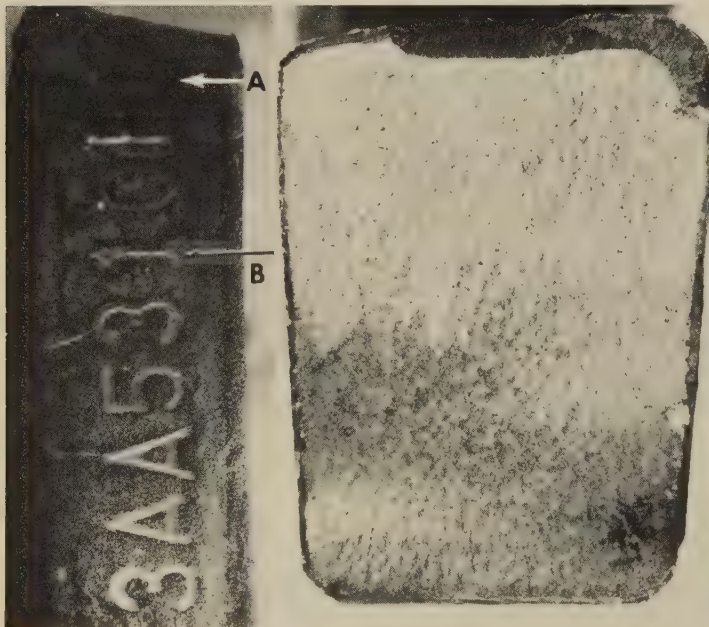
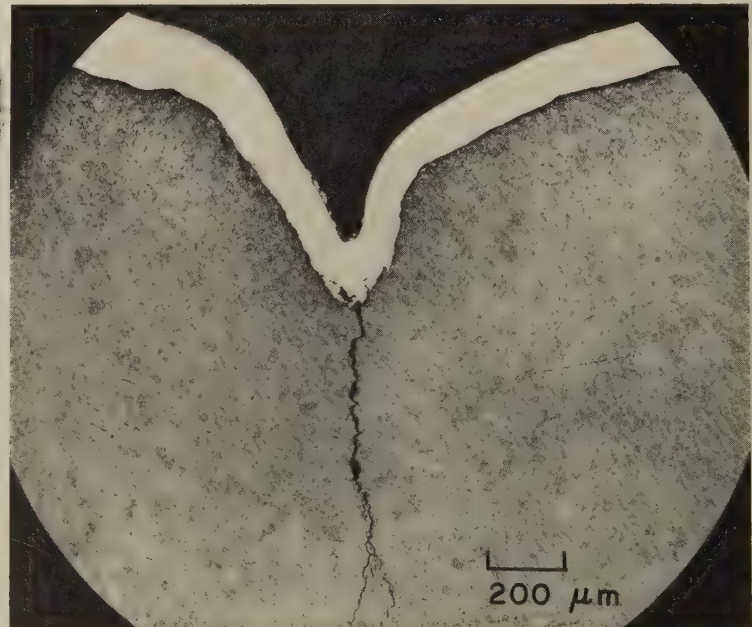
5044, 5045, 5046

Fatigue fracture in an experimental spring of 5160 steel with a hardness of Rockwell C 47.5 to 51.5. The spring had been fabricated to a roughly rectangular cross section and was broken in testing. The fine white lines in 5044 (left) are magnetic-particle traces of cracks caused by stamping of the identifying symbols. At top in 5044 is the surface of the fracture, which began at a crack that formed at the stamped numeral at arrow A. The fracture surface is shown also in 5045 (center), with stamped surface in profile at top; the fatigue zone (dark) is visible at top edge. At right (5046) is a section through the stamped numeral at arrow B in 5044. Note the crack, which formed at the numeral, in the steel below a protective nickel plate (light).

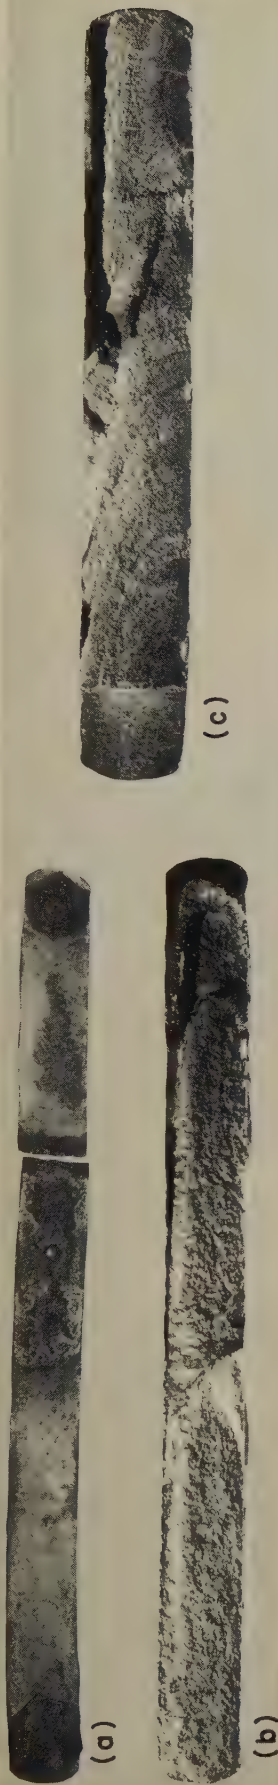
5047 At top left (a) is a view of one of the fracture surfaces of that broken leaf, showing a large fatigue zone. Although no fatigue marks are clearly visible, the fatigue-crack origin appears to lie at the lower edge, just to the left of the light triangular facet. Note the shear lip along the upper edge. At right (c) is a fracture surface of a similar but thicker leaf, also of 5160 steel, with a hardness of 415 Bhn. Two fatigue-crack origins are visible at the lower edge, one near each end. The dark region at upper right is a shadow of a shear lip.

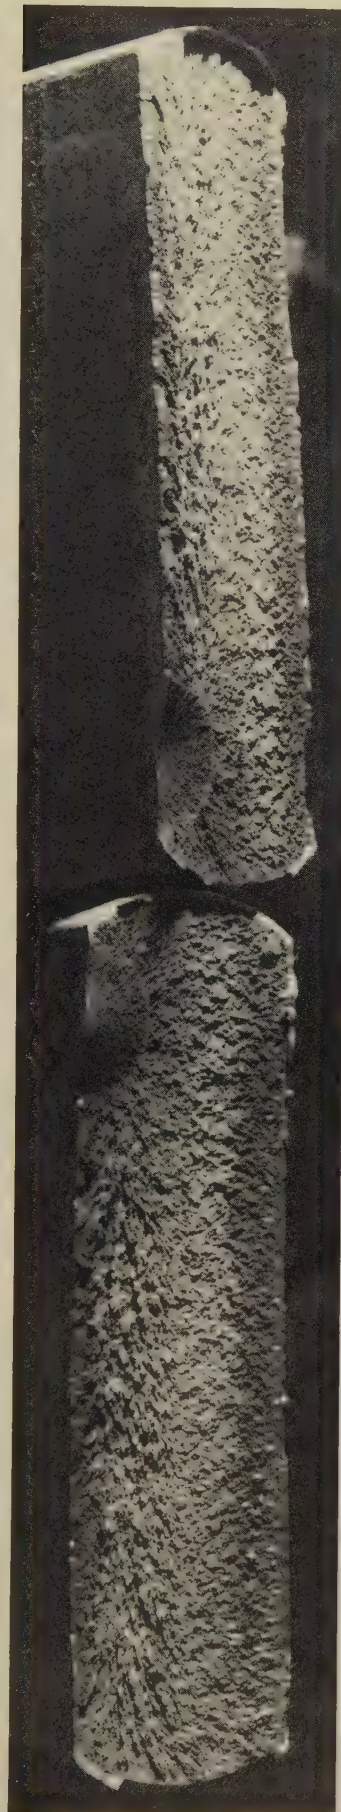
5048 Mating surfaces of a fatigue fracture in a leaf of a 5160 steel leaf spring with a hardness of 415 to 429 Bhn. The two segments of the leaf appear to have different thicknesses because the fracture surface of the segment at left is shown less obliquely due to the upward curve in that segment. The fatigue-crack origin is visible at the top of each fracture surface, near the edges shown adjacent here. A gouged region was found on the upper (tension) surface, in the area of the origin; the gouging was attributed to foreign material between this and an adjacent leaf. Metallographic examination disclosed a heavy concentration of globular oxide inclusions surrounding the origin.

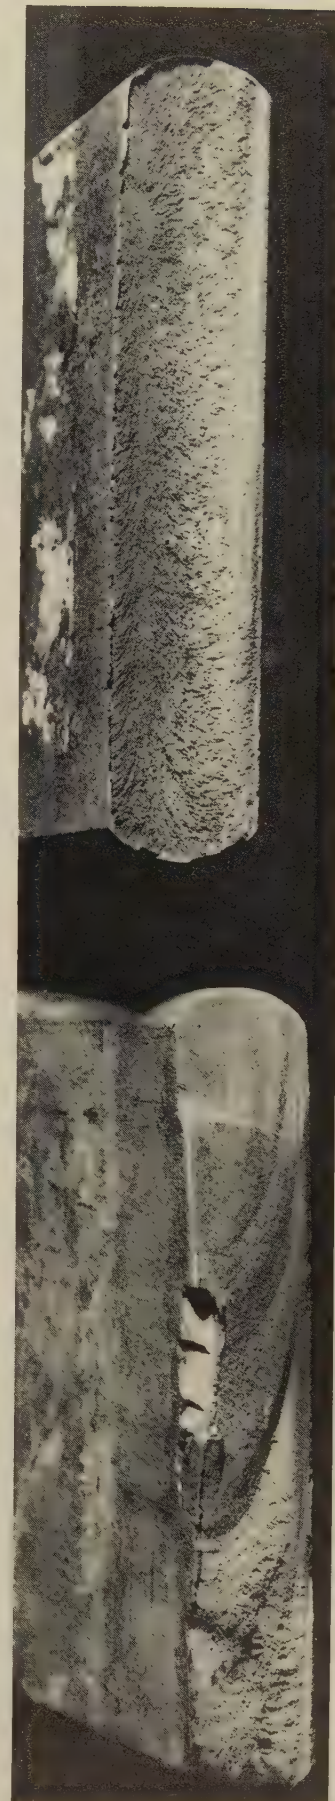
5049 Surfaces of fatigue fractures in leaves from two 5160 steel rear-bogie leaf springs. The leaf shown at left had a hardness of 371 to 381 Bhn, and the leaf at right had a hardness of 442 to 452 Bhn. The fracture surface of the leaf at left shows a fatigue-crack origin near the upper right corner, apparently at a surface defect. Beach marks show that the fatigue crack achieved nearly complete penetration before final, fast fracture occurred. The fracture surface of the leaf at right also exhibits a small fatigue zone at upper right, which is believed to have been initiated by deep-penetrating surface corrosion. Final, fast fracture occurred early, creating a very complete pattern of chevron marks.

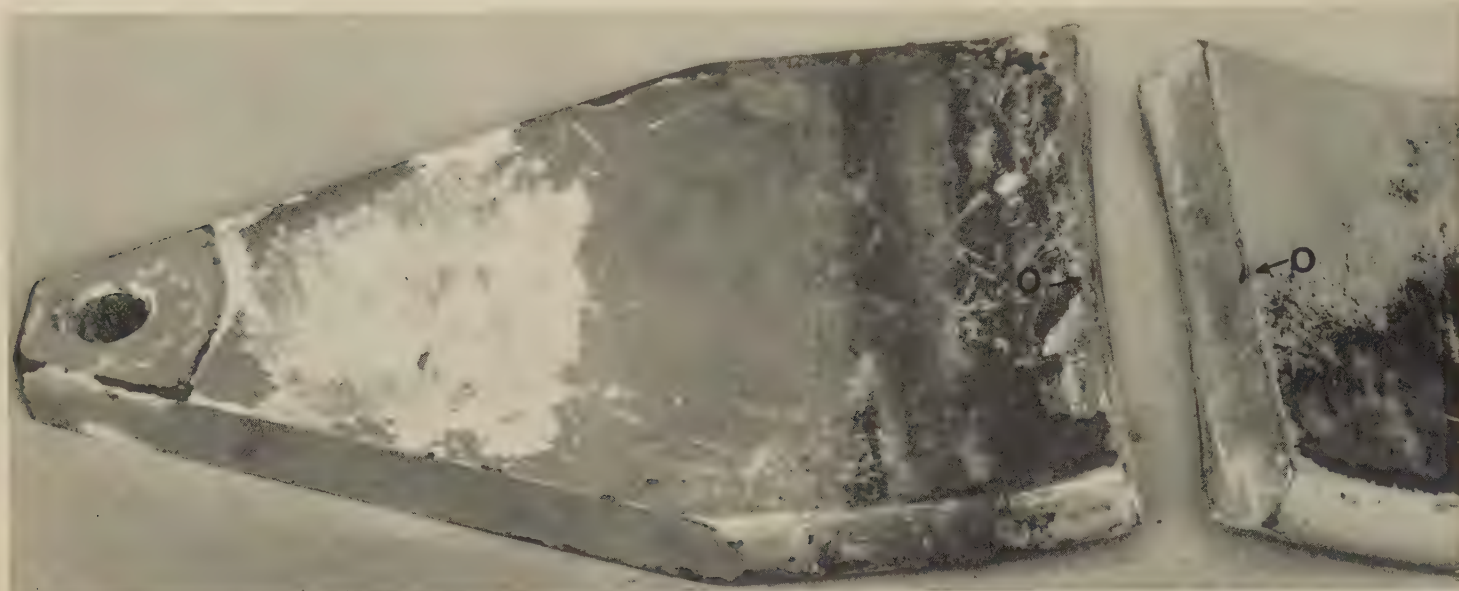
5050 Fatigue fracture in a 6150 steel spring leg of an aircraft main landing gear, heat treated to a minimum tensile strength of 1550 MPa (225 ksi) and a hardness of Rockwell C 49. Visual inspection of the fracture surfaces showed that the fatigue crack originated at the location marked by arrows O. The appearance of the external surface of the spring leg indicated that the part had been shot peened but that peening had been inadequate. The dimensions of the spring leg conformed to specifications. See also 5051 to 5055.

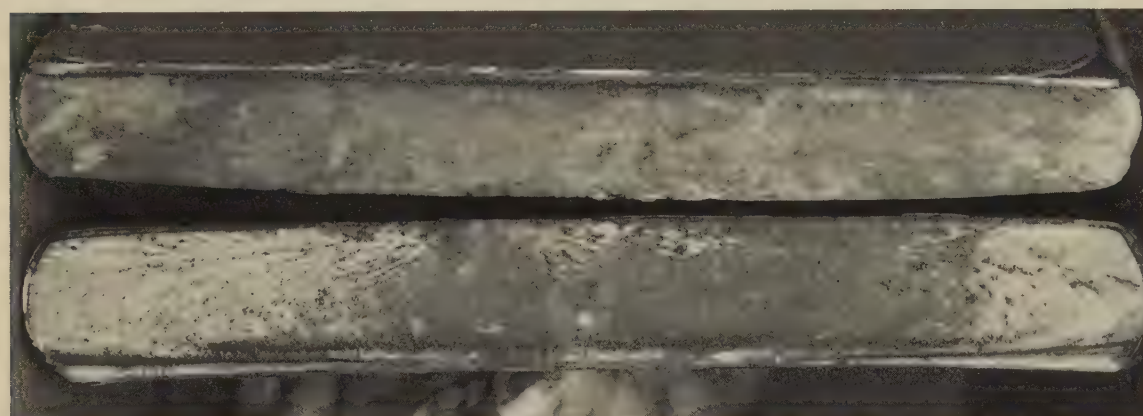
5051 Mating fracture surfaces of the broken main-landing-gear spring leg in 5050. A small fatigue zone can be seen just to the left of center, at the edges shown adjacent here. This zone grew to a length of only about 0.2 in., and to a depth of slightly more than 0.1 in., before final, fast fracture occurred. The remainder of each fracture surface shows features typical of rapid tearing.

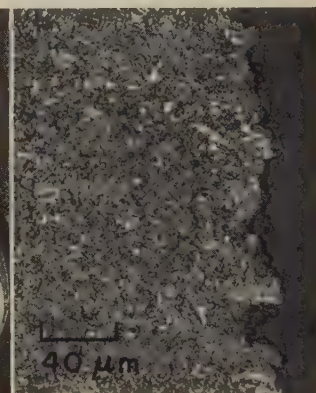
5052 Section through the spring leg in 5050, showing the irregular profile of the fast-fracture surface, at right.

5055 Another section through the spring leg in 5050, showing a profile of the fatigue-crack surface, at top. Compare the smoothness of this surface with the irregularity of the fast-fracture surface in 5052.

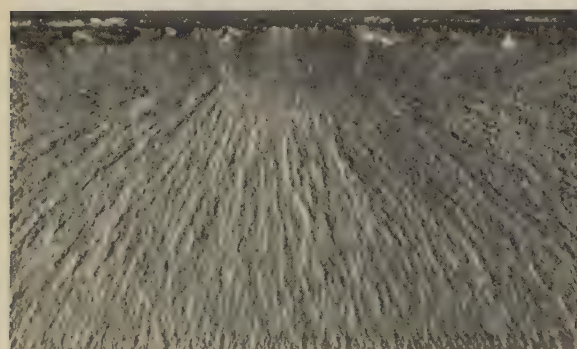
5053 A view of the fracture surface at bottom in 5051, showing the fatigue zone at top center. Metallographic study of this region revealed partial decarburization to a depth of 0.028 in., which contributed to fracture.

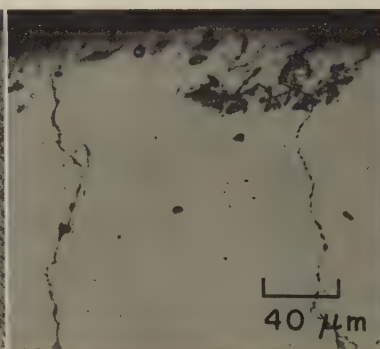
5054 Section through the spring leg in 5050, near the fracture origin. Secondary cracks extend inward from the shot-peened surface (at top).

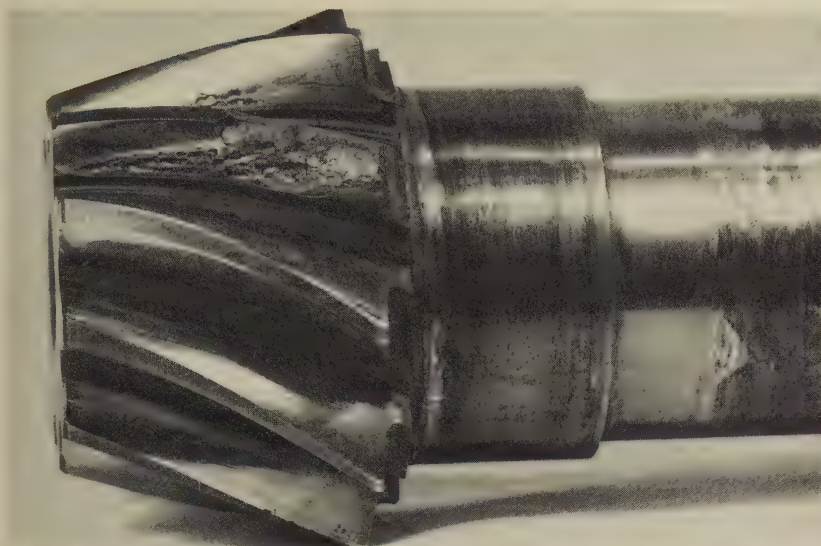
Photograph 3/4×
5056 Bending-fatigue fracture in the heel of one tooth of a spiral bevel pinion of 8617 steel, carburized and hardened to Rockwell C 57 in the case. Fracture resulted from severe pitting. Note that pitting had begun in an adjoining tooth (near top).

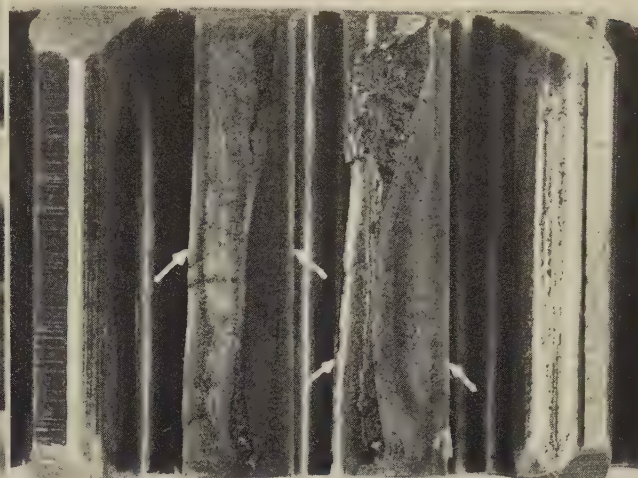
Photograph About 2×
5057 Bending-fatigue fracture in two teeth of a reverse idler gear of 8617 steel, carburized and hardened to Rockwell C 60 in the case. Arrows point to root fillets on both sides of each tooth, where fracture began because of excessive stress in these locations.

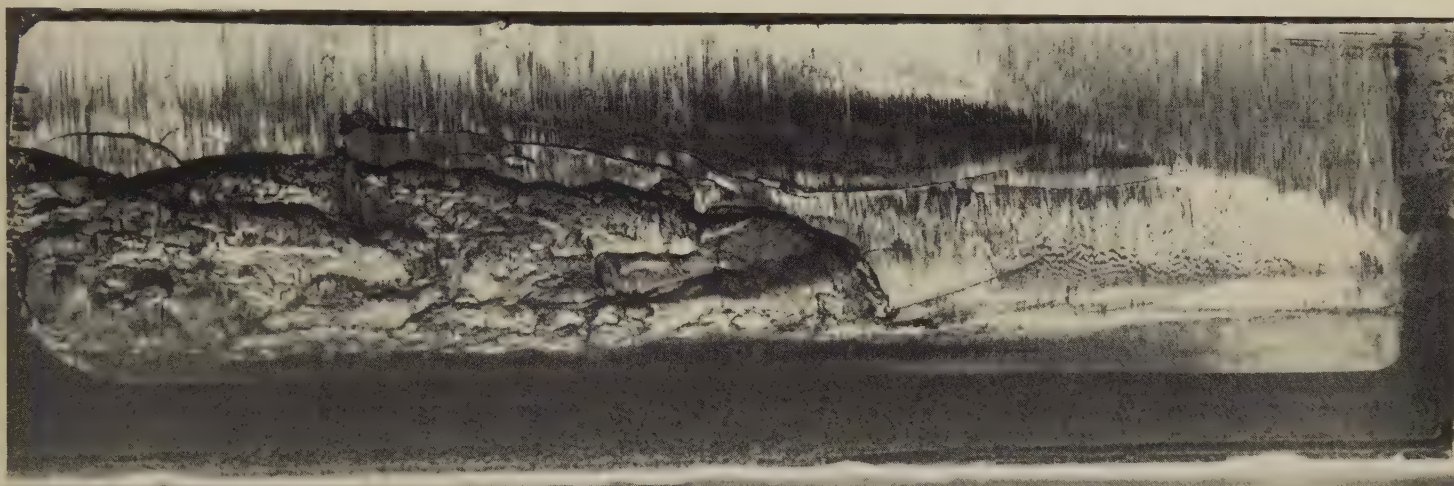
Light fractograph About 4×
5058 Surface of a spalling-fatigue fracture in a single tooth of a heavily loaded final-drive pinion of 8620 steel, carburized and hardened to Rockwell C 60 in the case, showing vertical scratches, which indicate that appreciable abrasive wear took place also. The surface ripples at right suggest that a small amount of plastic flow occurred under the applied load.

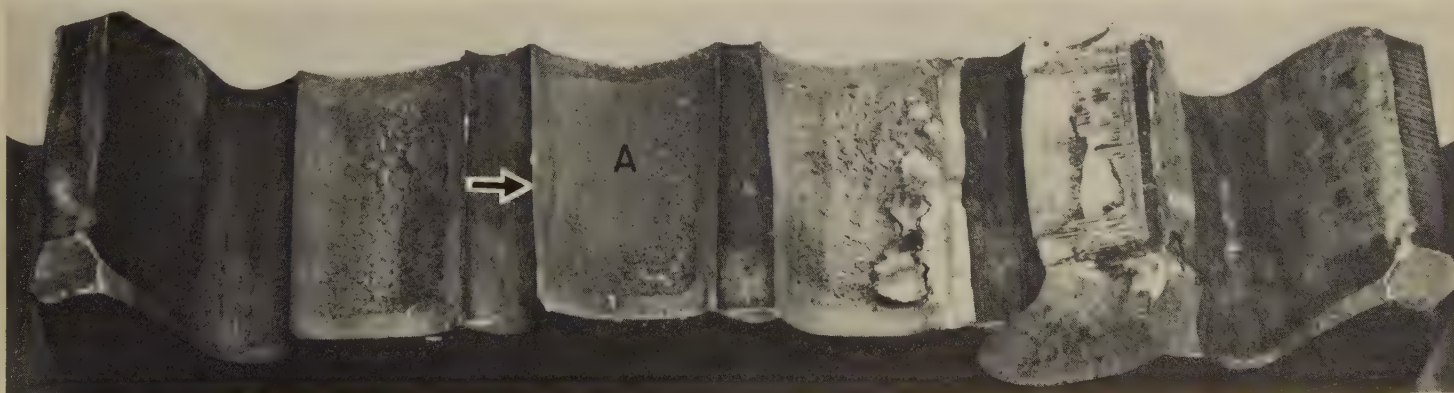
Photograph 2×
5059 Bending-fatigue fractures in several teeth of a spur gear of 8620 steel, carburized and hardened to Rockwell C 60 in the case. The tooth marked A apparently broke first, as the result of a fatigue crack that originated in the fillet to the left of the tooth (arrow). After this tooth broke off, fracturing of the teeth on each side of it was accelerated.

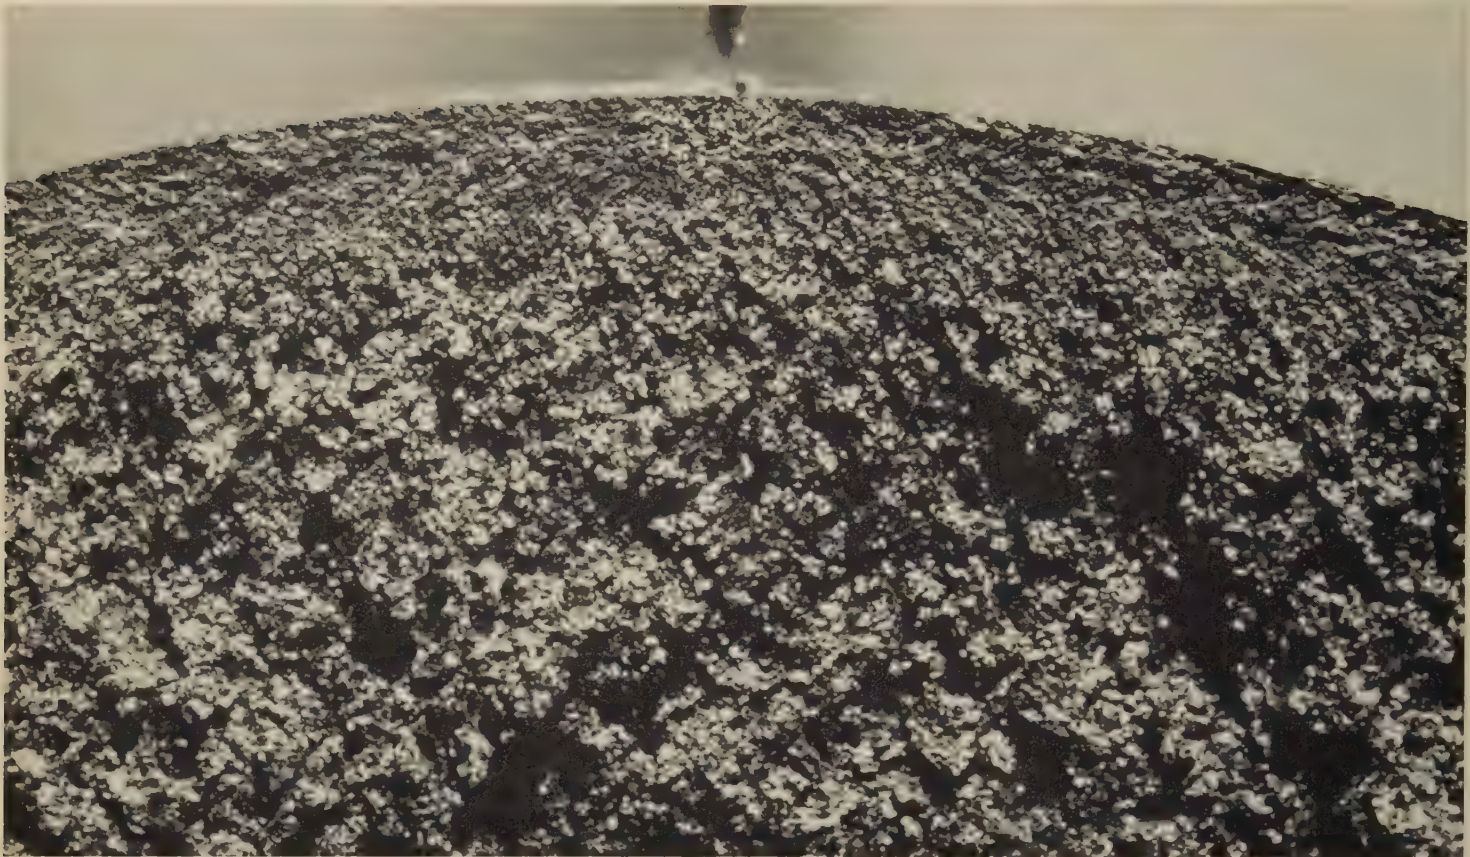
5060 Fracture surface of a 1¼-in.-diam kingpin of 8620 steel, carburized and case hardened to Rockwell C 57 to 63, then broken in a laboratory by a single overload. Chevron marks are faintly visible in the case and point to the fracture origin, at top center (indicated by pointer). Compare with the fracture surface in 5061 (below).

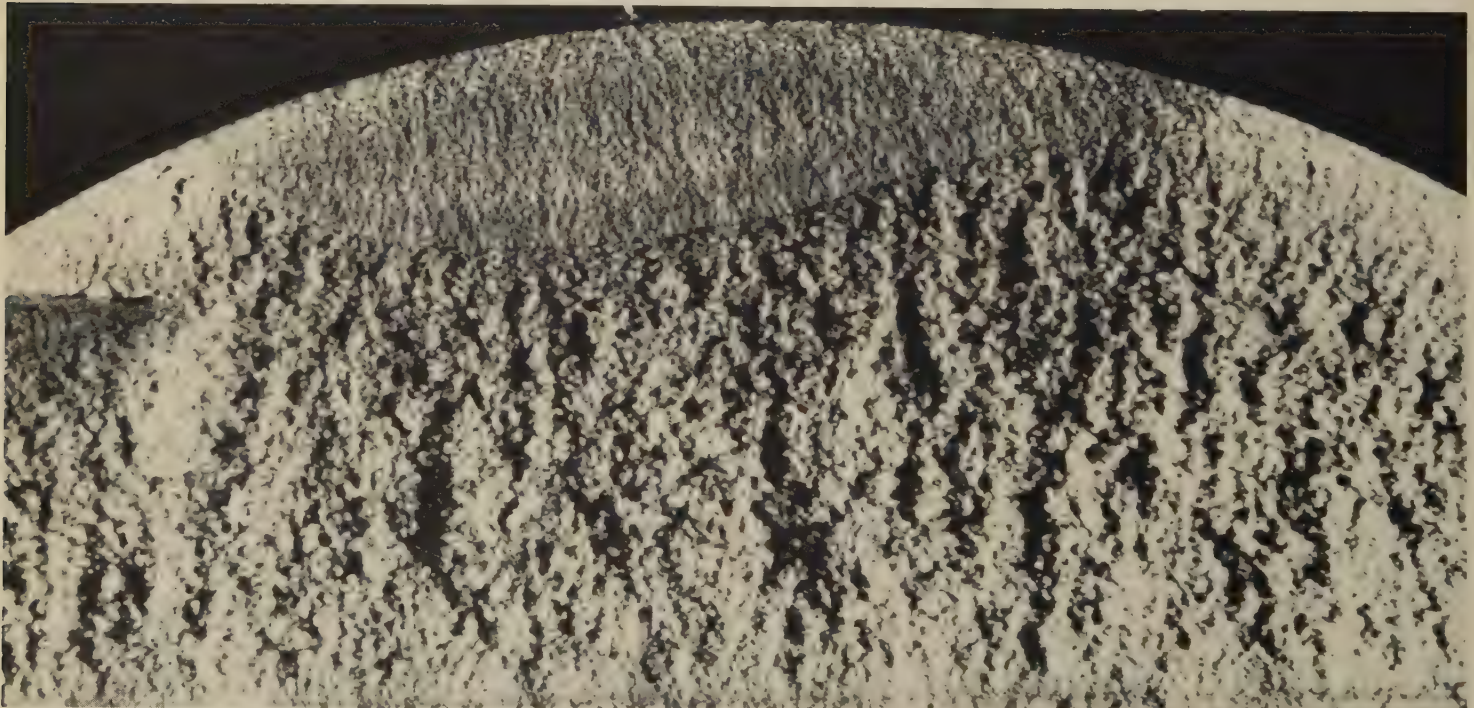
5061 Fracture surface of a 1½-in.-diam kingpin of 8620 steel, carburized and case hardened to Rockwell C 57 to 63. Laboratory bending-fatigue testing resulted in a fatigue crack, which was then broken open by a single overload. Note that the fatigue zone (at top) has a texture much smoother than that of the overload region, which constitutes the remainder of the fracture surface.

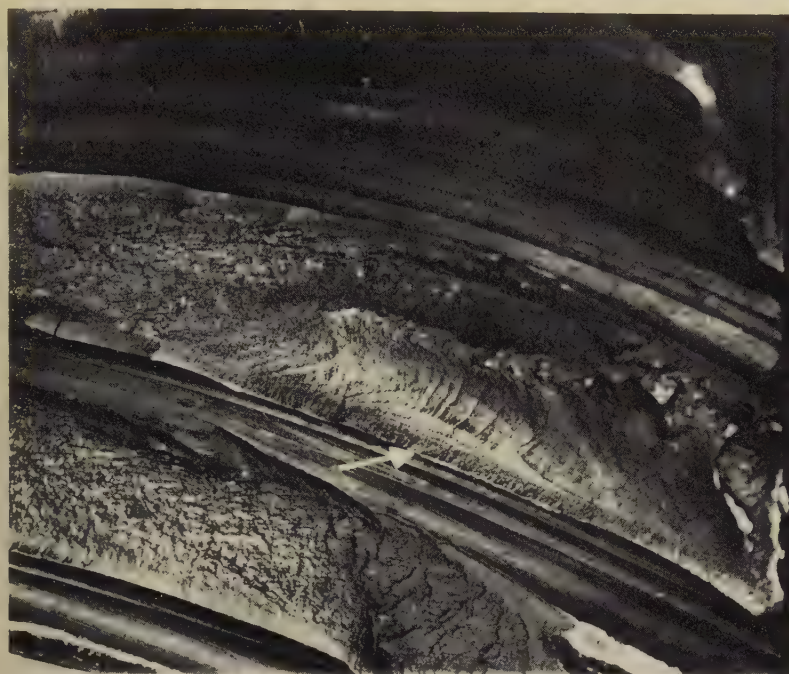
Light fractograph 1.65×
5062 Surface of a bending-fatigue fracture in a tooth (upper tooth in this view) of a large spiral bevel pinion of 8620 steel carburized and hardened to Rockwell C 60 at the surface. The arrow marks the fatigue-crack origin, in the root fillet. The absence of this tooth resulted in fracture of the tooth below by overload.

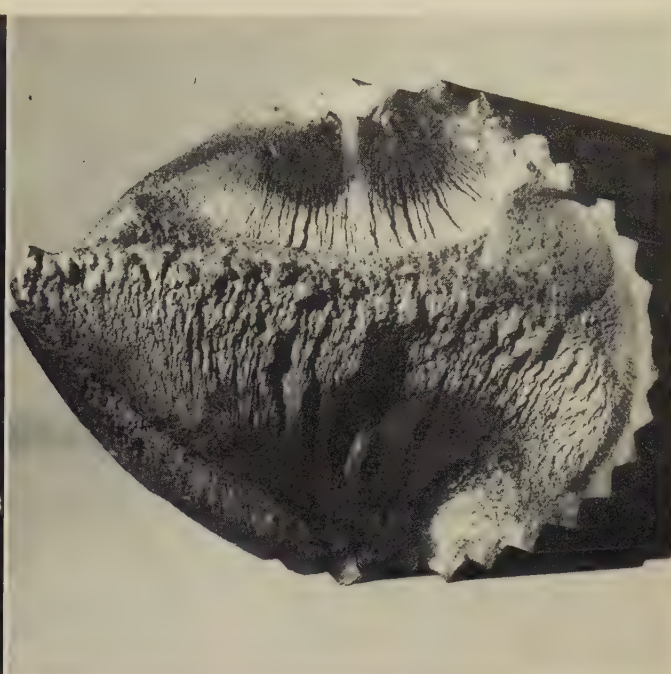
Light fractograph 2×
5063 Surface of a torsional-fatigue fracture in a splined shaft of 8620 steel that was carburized and case hardened. Multiple fatigue cracks evidently formed at the roots of the splines and then joined to penetrate much of the case before final, fast fracture occurred.

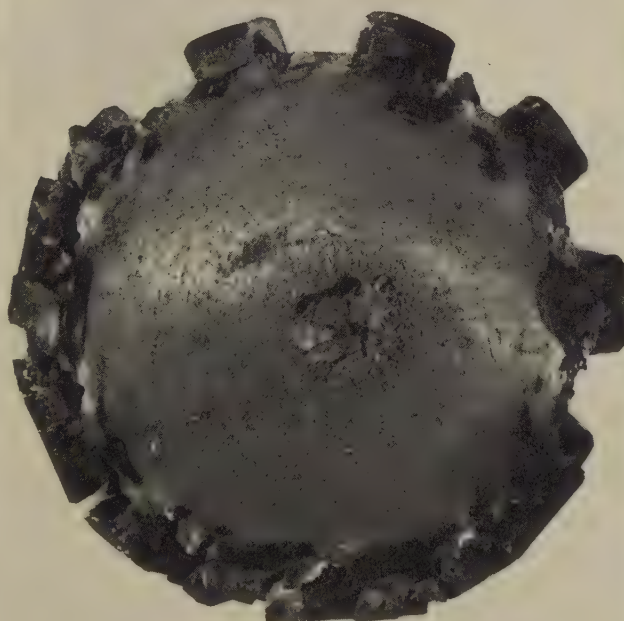
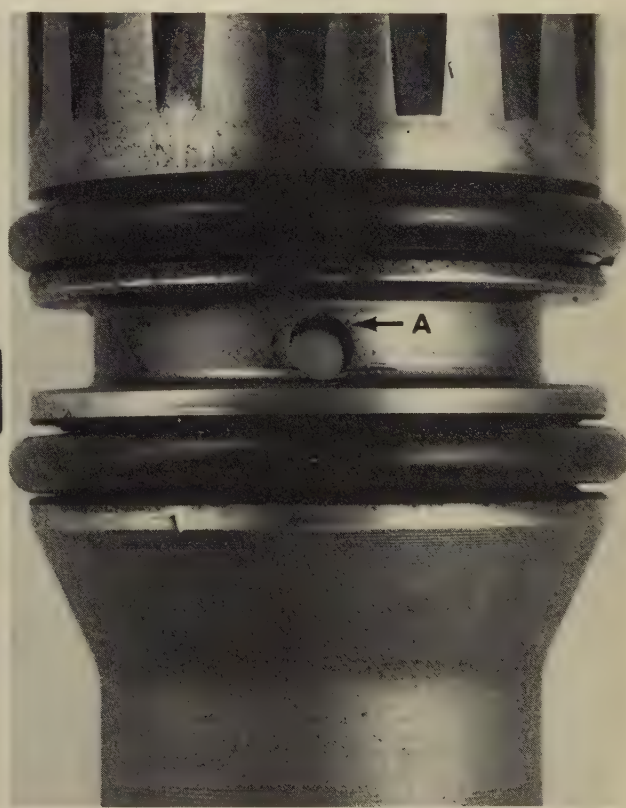
Photograph 1/4× Light fractograph 1 1/2× Photograph 1 1/2×
5064, 5065, 5066 At left (5064) is a view of a broken splined shaft of 8620 steel, surface carburized to a case depth of 0.042 in. and hardened to Rockwell C 63 to 65; core hardness was Rockwell B 96. Specified case hardness was Rockwell C 57 to 62. The fracture resulted from torsion overload. At center (5065) is a view of a surface of the fracture in 5064. Brittle fracture of the splines occurred first; later, the soft, ductile core fractured in the transverse shear plane. At right (5066) is a view of the O-ring region of the shaft in 5064. A 45° torsion crack is visible (at A) at the edge of an oil hole; this crack is proof of the torsional nature of the loading that was imposed on the shaft.

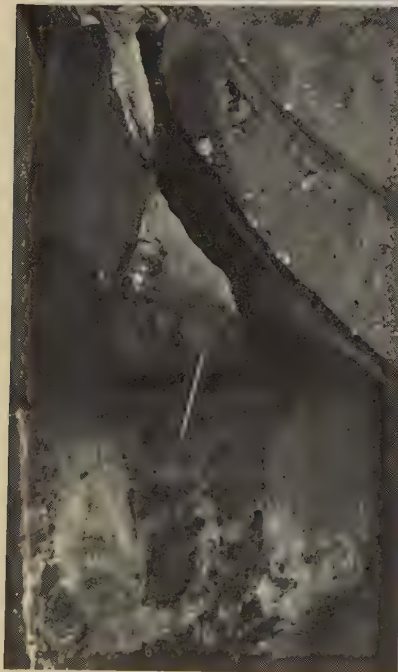
5067, 5068, 5069

A fatigue fracture in the arm of a coil grab that broke after seven years of service. The arm had been cast of 8620 steel, quenched, and tempered to a hardness of Rockwell C 25. Magnetic-particle inspection of the arm had been performed annually during six years of service, so the crack must have developed sometime during the final year of service. At left (5067) is a view of one segment of the broken arm, with a flexible shoe (left) still attached. Clearly visible on the larger flange is the fatigue zone, which originated at the arrow, at sand pockets near the surface that acted as stress raisers. At center (5068) is a view of the coil grab minus the arm segment in 5067. The fatigue-crack origin is at the bottom in this view. At right (5069) is a view of both segments of the broken arm, showing the fracture surface in 5068. Not visible is a repair weld on the underside, as viewed here, near the crack origin. See also 5070 and 5071.

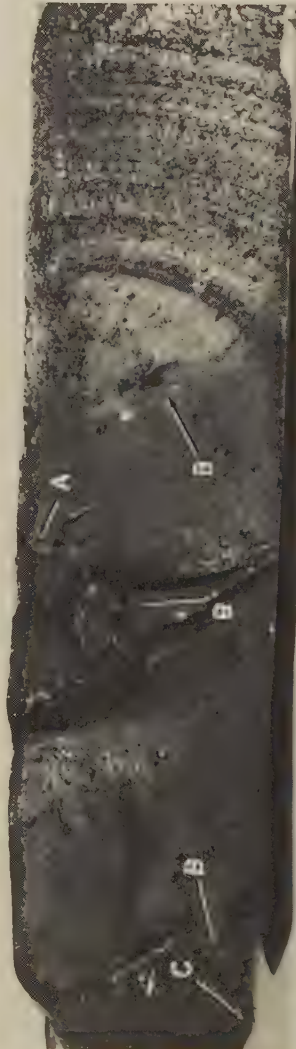
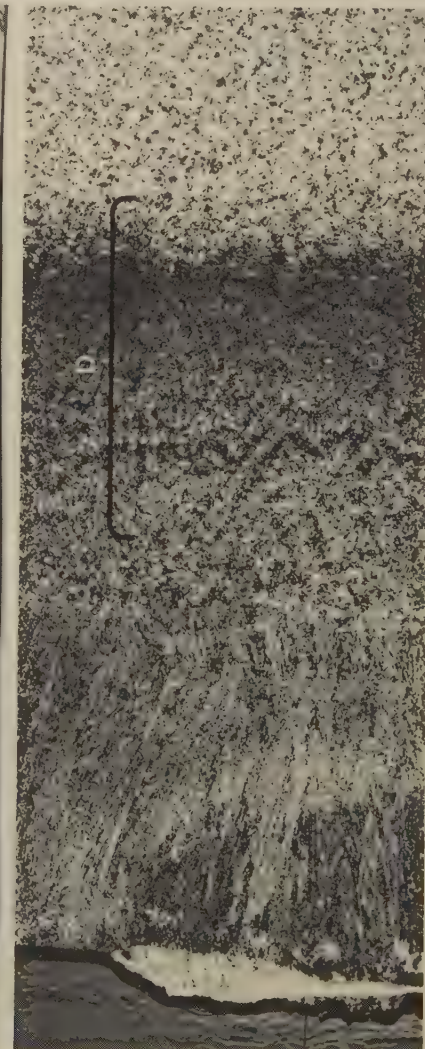
At top (5070) is the portion of the fracture surface in 5068 and 5069 that includes the fatigue-crack origin (at arrow A). This portion was sliced from the outer edge of the larger flange of the broken arm; the cut surface is in profile at bottom here. Sand pockets exist near the origin and elsewhere (at arrows B). The repair weld (at arrow C) was made after the casting had been heat treated, as shown by the presence of a dark heat-affected zone at D in 5071 (at bottom), which is a polished and etched section through the weld.

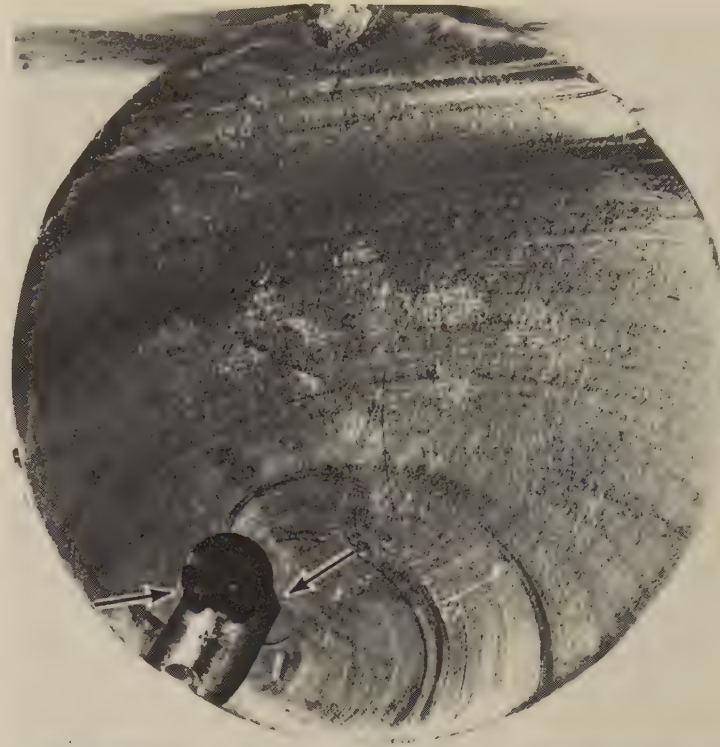
5072

About actual size
Surface of a fracture in a boom-point pin that broke during service. The material is 8640 steel that was quenched and then tempered to a hardness of 269 Bhn. Sharp corners of mismatched transverse grease holes provided stress concentrations that generated two fatigue cracks (arrows). The front that was formed by the merging of these two cracks nearly penetrated completely across the pin before final, fast fracture occurred.

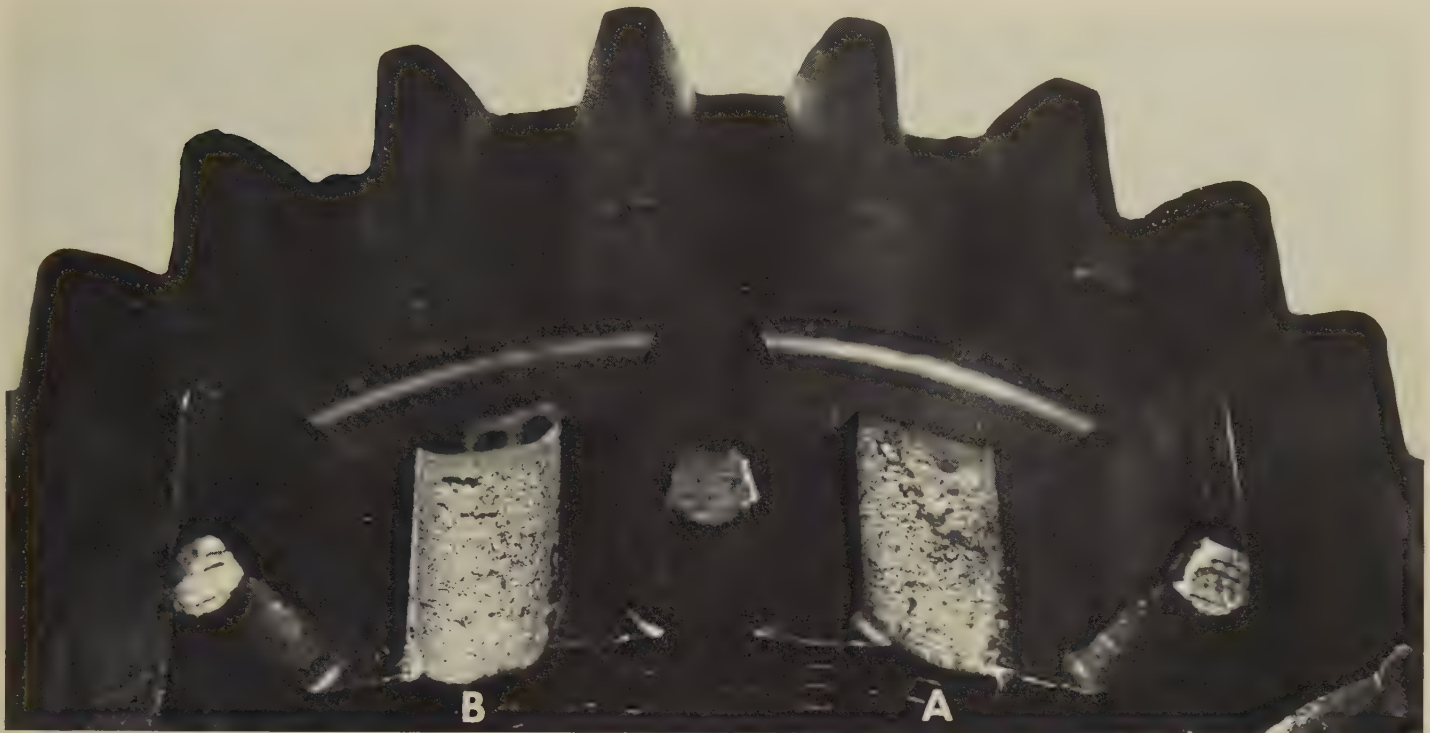
5073 Fractured cluster gear of 8620 steel, carburized and hardened to Rockwell C 60 in the case. The tooth at A fractured in service. The tooth at B was broken later, in a laboratory, by overload caused by the impact of a 100-lb weight dropped from several feet. The fracture surfaces of both teeth exhibit characteristics of cleavage and are very similar to each other, indicating that the fracture of the tooth at A was also caused by a sudden overload. 1½×

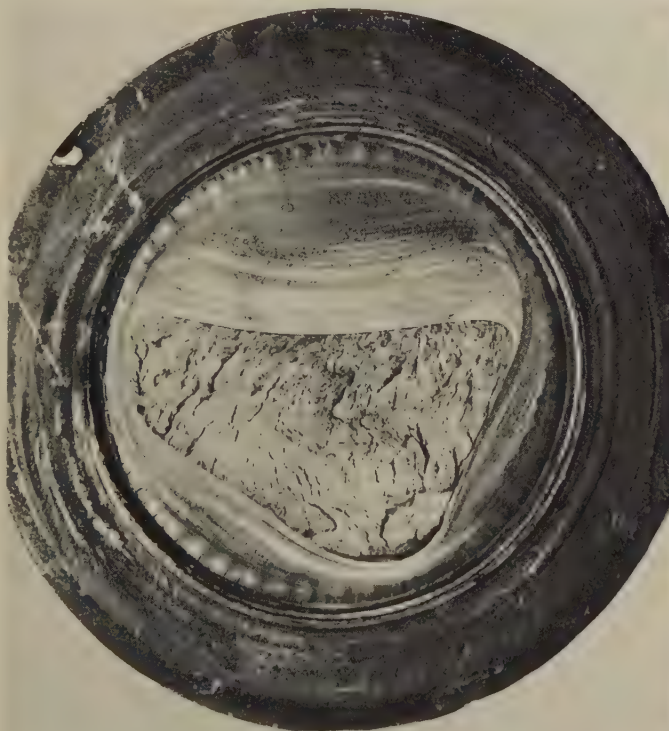
5074 Surface of a fatigue fracture in a 4-in.-diam axle of 8640 steel with a hardness of about Rockwell C 30. Contained within a shrink-fitted collar (visible here), the non-rotating axle was subjected to bending stresses in three directions, which produced this unusual pattern of beach marks. 0.65×

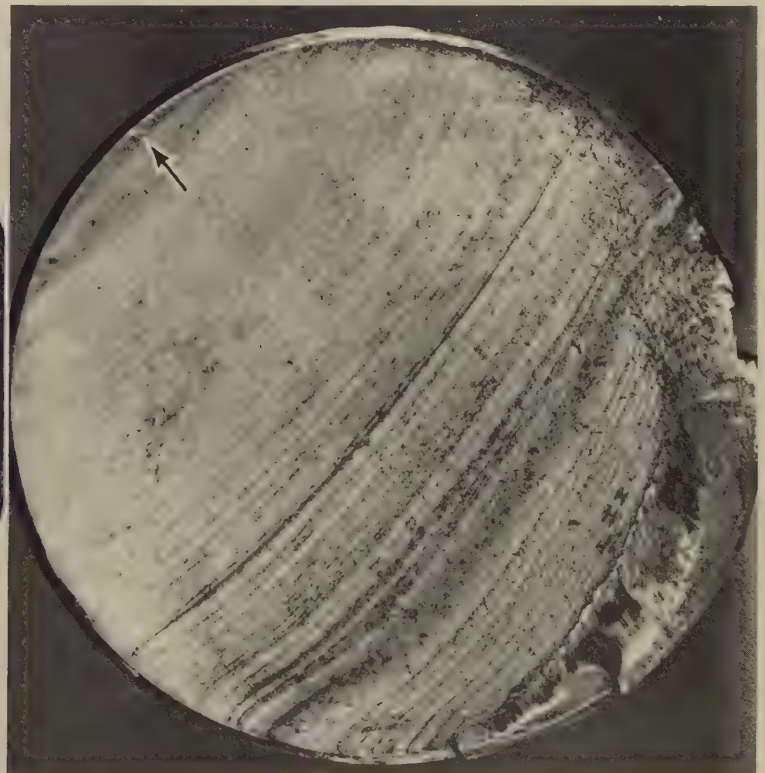
5075 Surface of a fatigue fracture in a nonrotating axle of 8640 steel with a hardness of approximately Rockwell C 30. Visible are beach marks, which indicate that the fatigue crack penetrated across more than 90% of the axle before final, fast fracture occurred. The origin (arrow) was at a discontinuity in a cut thread. About 0.95×

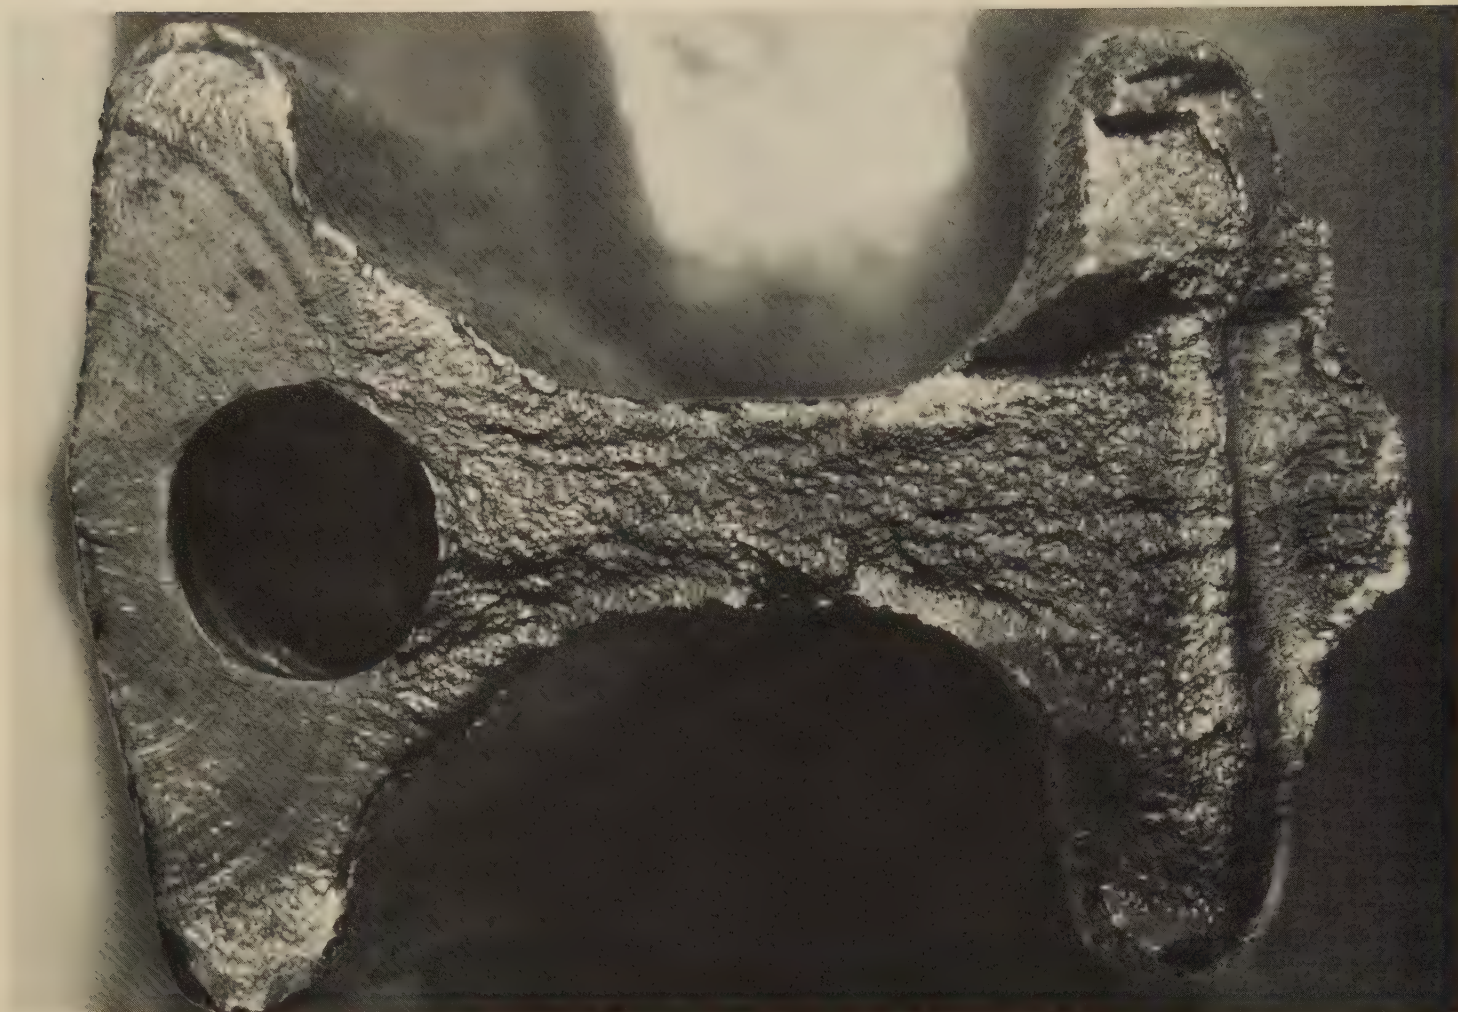
5076 Surface of a fatigue fracture in a forged connecting rod of 8640 steel with a hardness of Rockwell C 26 to 27 throughout. The rod broke after approximately 52,000 miles of service. The fatigue-crack origin is at the left edge, at the flash line of the forging, but no unusual roughness of the flash trim there was discovered. No metallurgical cause of the fracture was detected. The fatigue crack progressed about halfway around the oil hole at left before final, fast fracture occurred. Note the pronounced shear lip at the right edge.

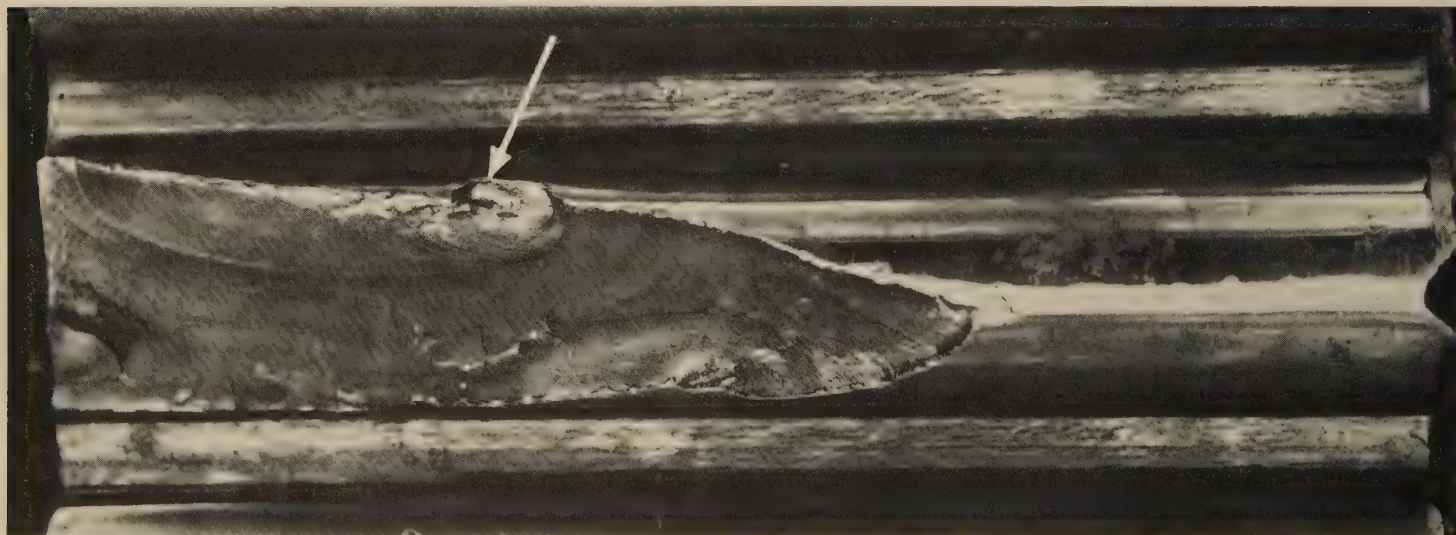
5077 Surface of a bending-fatigue fracture in a tooth of a sprocket-drive pinion of 8650 steel induction hardened to Rockwell C 58 to 60. The fatigue-crack origin is at a deep pit (arrow) in the tooth surface. Severe end loading produced other, smaller pits in the surfaces of the teeth. Beach marks indicate that the fatigue crack penetrated a large portion of the tooth before a piece broke off.
